**California Land Recycling Conference**  
September 17, 2025 @ 4:15

# **Collaborative Innovation in Complex Remediation: Solar-Powered SVE and Stakeholder Alignment at the Preco Site**

**Roohi Toosi, PE, President at Apex Environmental & Water Resources**  
**Mehmet Pehlivan, PG, CHG, Principal Hydrogeologist at JHA Environmental, Inc.**

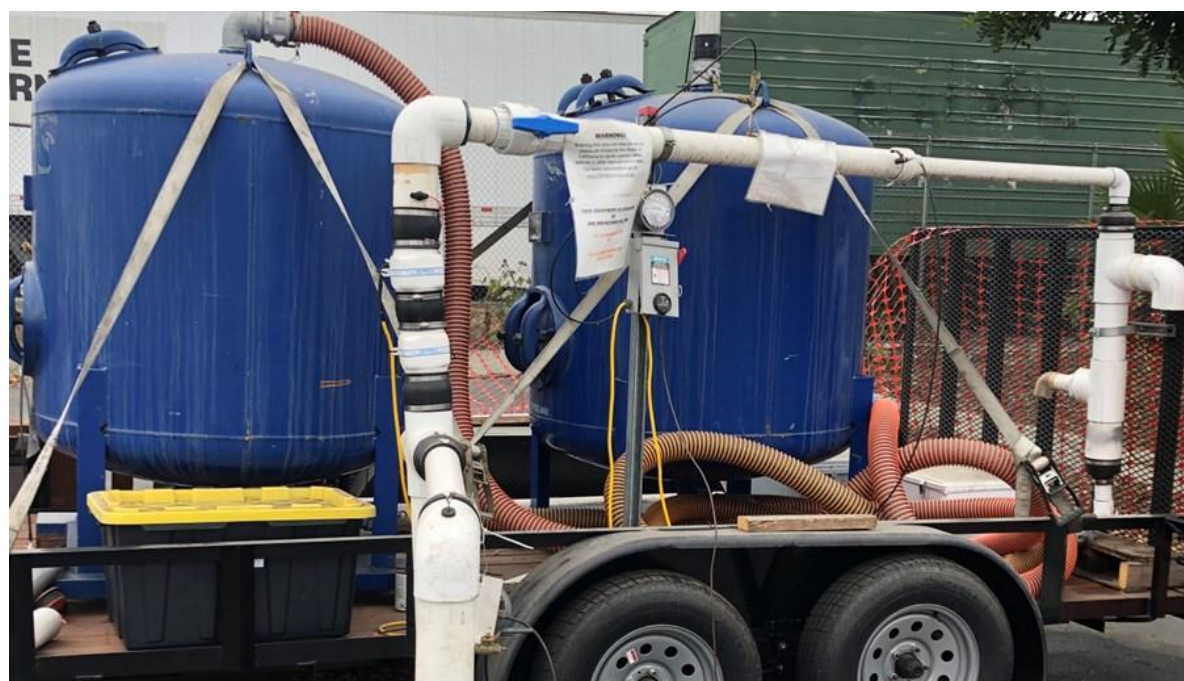
**Sailingflo 4" in-line  
Marine Bilge Air  
Blower 12V up to 270  
CFM capacity  
Centrifugal Bilge Fan**

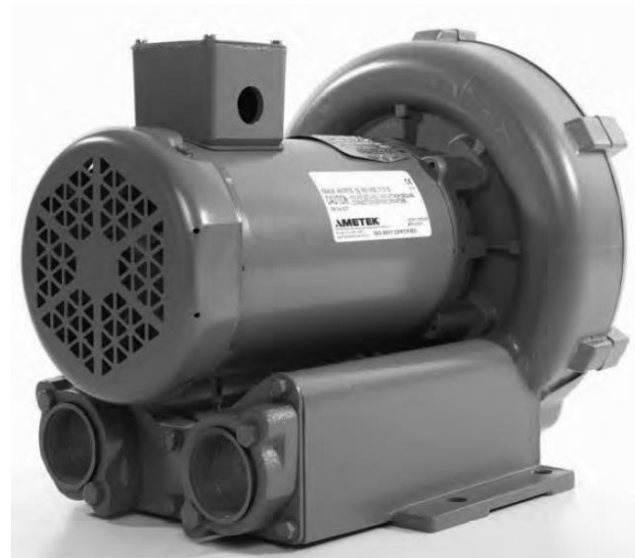
### DR 353 & CP 353

.75 HP Regenerative Blower

- Manufactured in the USA - ISO 9001 and NAFTA compliant
- CE compliant - Declaration of Conformity on file
- Maximum flow: 100 SCFM
- Maximum pressure: 50 IWG
- Maximum vacuum: 45 IWG
- Standard motor: 3/4 HP, TEFC
- Cast aluminum blower housing, impeller & cover; cast iron flanges (threaded)
- UL & CSA approved motor with permanently sealed ball bearings
- Inlet & outlet internal muffling
- Quiet operation within OSHA standards
